# A Tested Method for Mitigating Arc Flash Hazards in Existing LVMCC

Jim Bowen - Aramco

Andrew Ackerman - NEI Engineering

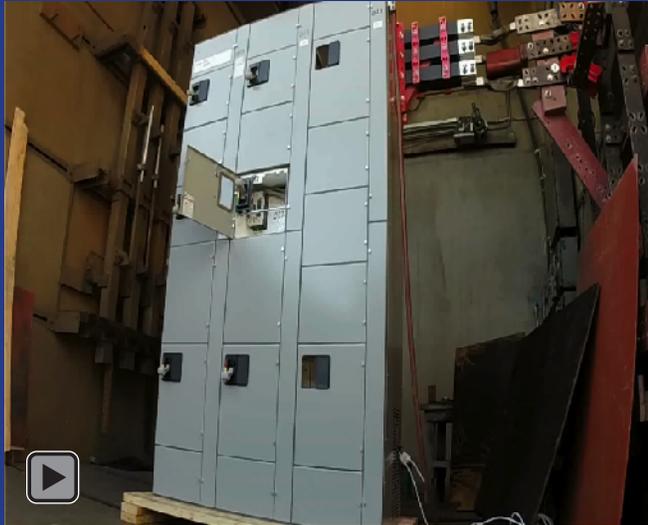
## Load Side Test - without the 4' of wire

This test was conducted to verify the open door results of a load side fault. Fine-strand bare #10 SIS wire was connected in a short-circuit between the three load terminals.

The test current was 65kA, the fault was cleared by the MCCB in 6mS. It is evident there is little or no arc-flash exposure in this configuration.

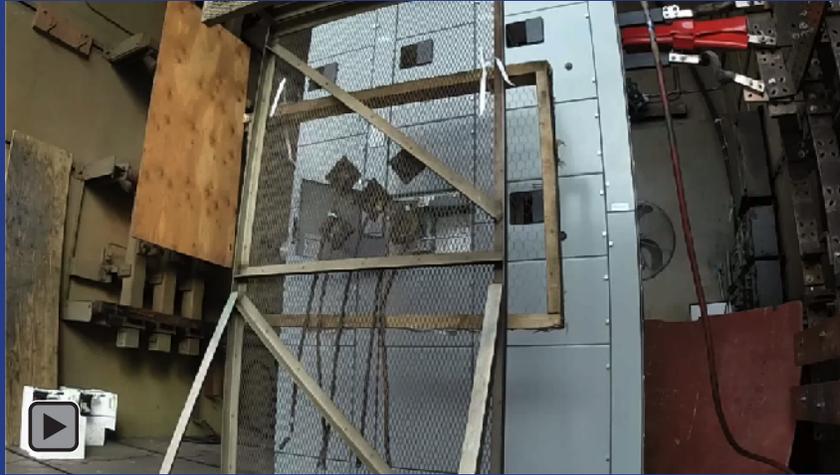
## Line side test – No modifications

Five calorimeters placed at 18” from front of open door to measure heat energy from fault through open door. The configuration is bare #10 fine-strand SIS wire in a short circuit in the line side breaker terminals (see Slide 16), simulating a fault that could occur by a technician mistake measuring incoming voltage or expulsion of a lead wire during a load side fault. The fault current for this test was 50kA.

Arc begins at the breaker and within ½ cycle propagates to rear bus through the bucket stab assembly and is cleared by Main Backup Breaker in 300ms. The calorimeter readings were in excess of 40 cal/cm<sup>2</sup>. The fault caused vaporization of approximately 12 inches of copper riser bus, resulting in heavy contamination of adjacent structures.

An fault of this nature would have significant safety impact on the technician working with the door open to troubleshoot a problem and result in a long MTTR,

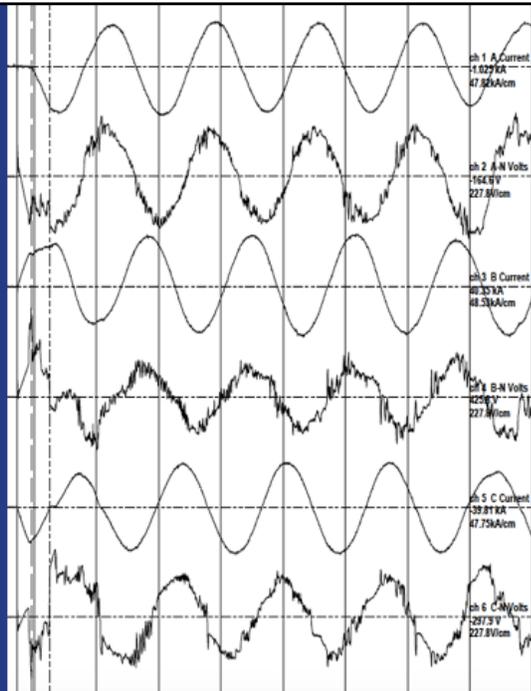
## Line Side Bucket Fault (no mods)

- Ignition wire from B to C vaporizes in 1/8 cycle
- Arc engages A phase <1/4 Cycle
- Fault Propagates to riser bus in 3/4 Cycle
- Continuous 3 phase arcing fault until breaker clears

Waveform layout from top - A current, A-N Voltage, B current, B-N Voltage, C current, C-N Voltage  
Fault was initiated B-C phase, vaporized and initiated A phase within 1/8 cycle  
Propagates to rear bus in 3/4 cycle where it continued until Main Backup Breaker de-energized circuit

This would model a typical LVMCC failure in a plant application without modifications. The result would be catastrophic equipment damage, resulting in process interruption and significant downtime.

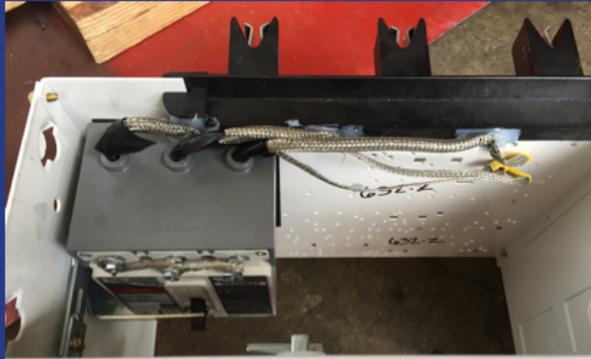
## Bucket Upgrades

We did find several instances where stab alignment caused issues under fault conditions. Improper insertion can break the clamshell support or deform one side of the stab. We have also witnessed the stab assembly missing the riser bus completely only contacting the outside of the stab – making it electrically conductive but totally ineffective under fault conditions leading to bus compartment failure.

- Sealed clamshell prevents propagation to rear riser bus
- Stab alignment pre-insertion important

When sealing the clamshell, a centering jig to assure proper alignment is recommended.

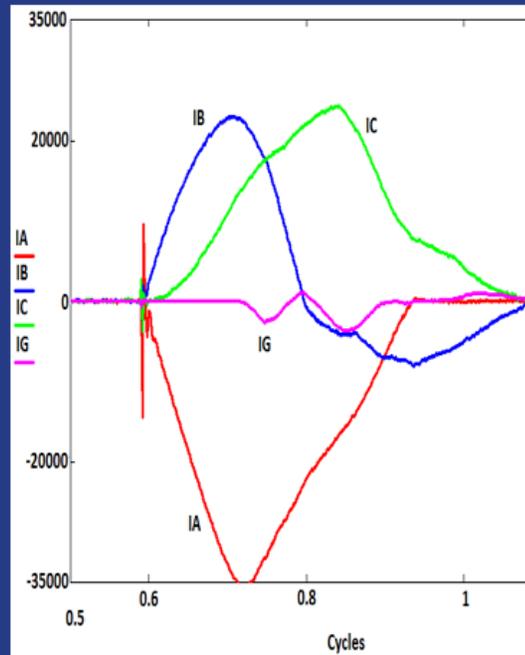
## Line Side Bucket Fault w/ Upgrades

- Wire vaporizes in 1/5 cycle
- Arc engages grounded braid
- A phase extinguishes 1/8 cycle later
- Arc extinguishes < 1/2 cycle after fault initiation
- Repeatable - All 20 trials less than 1 cal/cm<sup>2</sup>
- No fault restrikes

This profile was typical of all 20 tests after modifications were made to buckets.

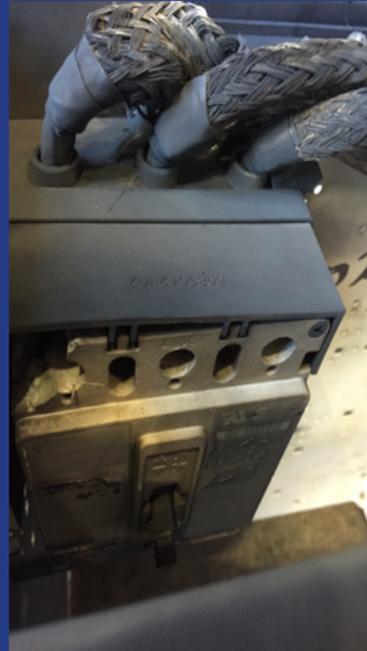
## Test Observations

- Sealed stab assembly clamshell prevents propagation to rear riser bus
- Breaker cap prevents arc development at breaker terminals
- Braided shield forces short path ground faults

One question that is asked concerns the thermal impact on the MCCB with the breaker cap installed. Manufacturers do not publish any derating factors in their application literature and the true heat sink is the connected devices and cables on the load side of the breaker. The damage shown above is somewhat exaggerated due to the connection method used to install the ignition wire. Note that all hardware vaporized during the fault, potentially leading to the corner of the breaker cracking. The shield wires would have eliminated any potential propagation between phases by their short path to ground, reducing any fault propagation between phases to a ground fault.

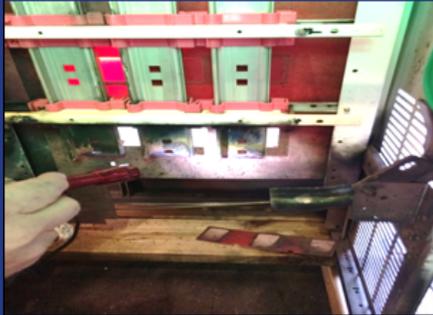
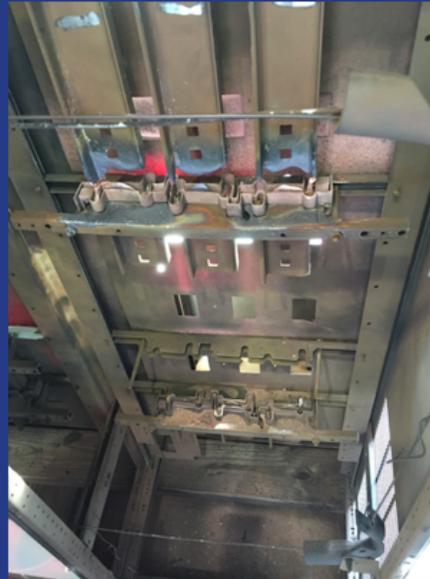
## Arc Flash Relay- Results

These photos are the actual riser buses after faults. The photo on the right shows a rear compartment with the riser bus after three trials. The area that appears blue towards the top of the photo is indicative of the copper vaporization under fault conditions after the AFDR modifications were done. Test performed in previous trials before the modifications were developed typically vaporized 9-16 inches of riser bus. After developing and installing the AFDR modifications, this was the typical result – the riser bus didn't completely burn through, the left hand side actually had to be cut with a cut-off wheel and copper vaporization was limited to less than two inches as indicated in the photo. This greatly reduces the area of contamination after a fault, reducing the MTTR. During the trials, we could remove the access panels, cut the riser bus, disconnect the source splice plates, megger the bus (typically 11MOhms), install the next test device and attach the access panels in less than one hour. We did have rear access to do this, but the point is that in a critical situation the time is greatly reduced. In a real world setting you could say getting back online in days instead of weeks.

The photo on the left is indicative of the discussion on the previous slide, where a fault in section two resulted in indication of the arc rooting at the last support in section three – the most distant point in the bus structure from the source. While not catastrophic in nature, it should be noted this phenomena exists when doing MTTR repairs as there could be damage in structures distant from the faulted section.

Insulating the ends of the main horizontal bus is required as the faults witnessed typically flow away from the source and can root to the adjacent metal cover or support. Manufacturers do not typically install insulation on the ends of the LVMCC bus, as it is assumed additional structures could be added. Adding insulation to the bus ends will not allow a bus fault to engage the metal structure. It is worth noting that some manufacturers actually add a small extension to their new arc flash LVMCC offerings to keep this phenomenon from occurring.

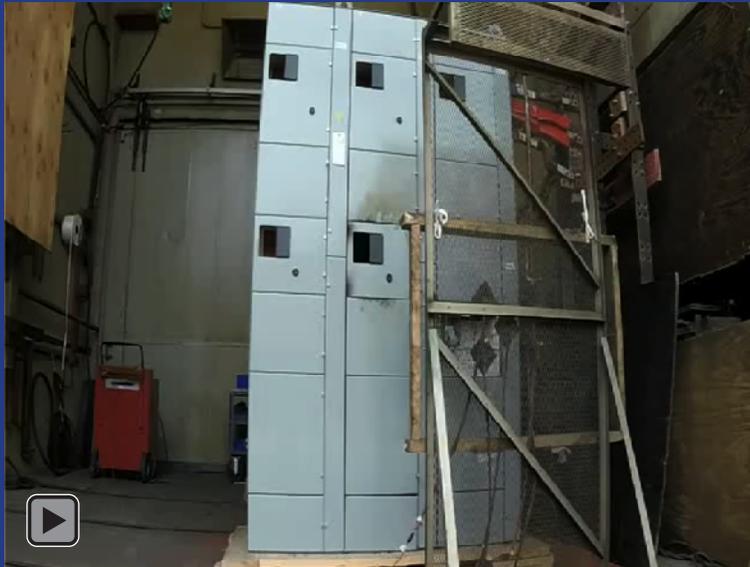
## Line Side Fault - with Upgrades

This is the combined result of the modifications in a Line Side fault. This is a 65kA fault, duration 9ms , the average calorimeter reading was .32 cal/cm<sub>2</sub>.

If you will refer back to Slide 21, the bare SIS and the 8/32 hardware vaporize, which is indicated by the sparks seen around 01:59 of the video.
