# A Tested Method for Mitigating Arc Flash Hazards in Existing LVMCC

Jim Bowen - Aramco

Andrew Ackerman - NEI Engineering

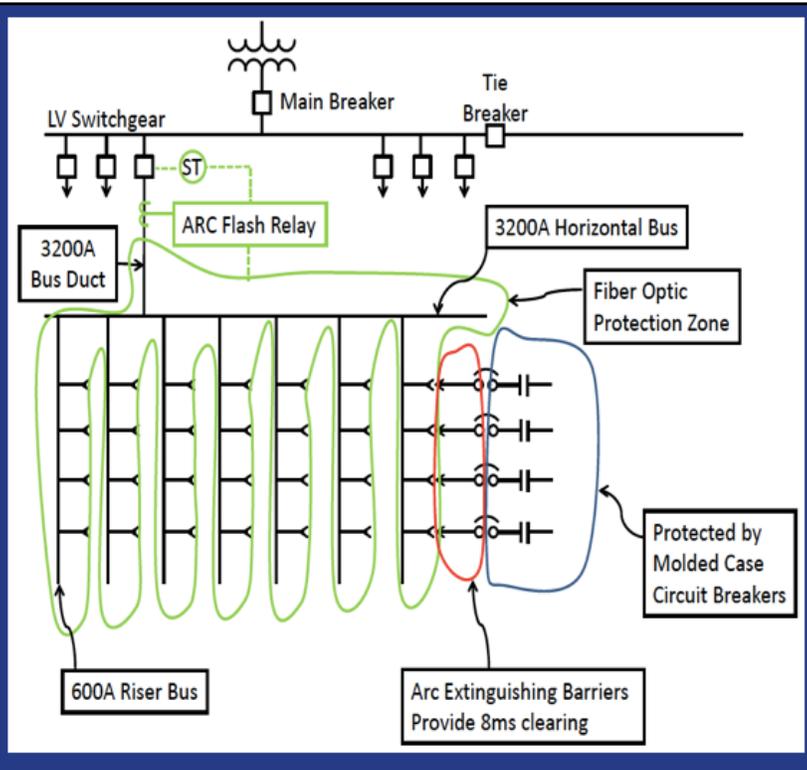
MCCB did show degradation for this close in fault but still performed well. This had to be confirmed since the UL testing requires the addition on the 4feet of rated wire to assure the feeder wire is protected by the components under test. In typical troubleshooting activities, the components are accessed at the terminals, creating the possibility of a close in fault condition.

The line side test is not part of the normal UL tests. It was included in our testing because the line terminals are accessible and energized when the MCCB is in the off position and the door is open, creating a potential shock and arc flash hazard.

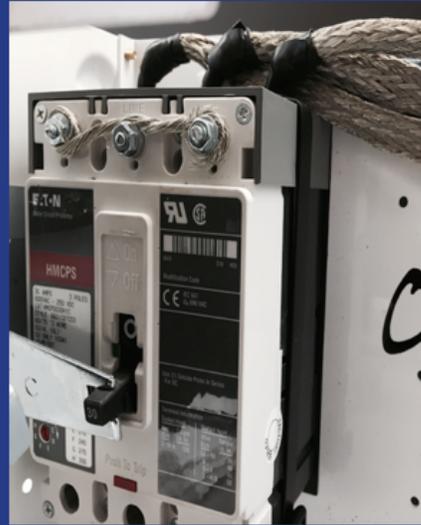
Lugs on line side of breaker were drilled and tapped to accept 8-32 screws to provide access for wrapping fine strand #10 SIS bare wire to short-circuit terminals for test.

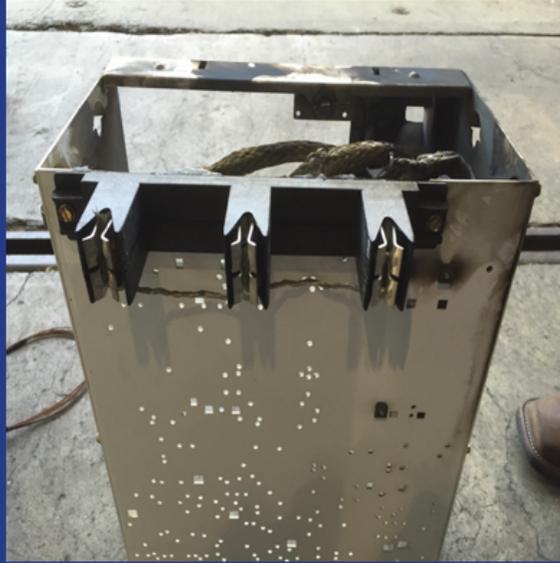
The #10 fine-strand bare SIS was installed by wrapping it through and around the stab assembly, creating a direct short circuit at the riser bus. This allowed the test plan to evaluate the arc flash relay application performance.

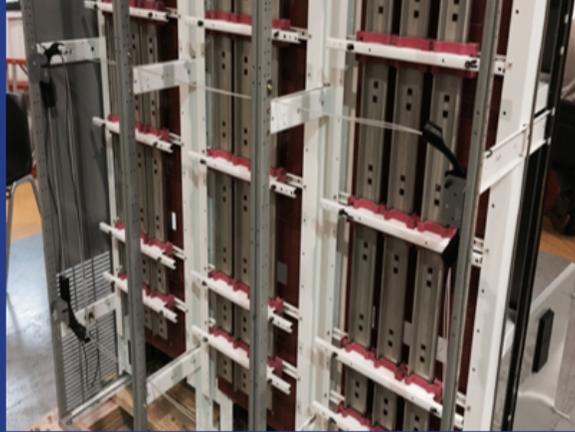
Insulating the ends of the main horizontal bus is required as the faults witnessed typically flow away from the source and can root to the adjacent metal cover or support. Manufacturers do not typically install insulation on the ends of the LVMCC bus, as it is assumed additional structures could be added. Adding insulation to the bus ends will not allow a bus fault to engage the metal structure. It is worth noting that some manufacturers actually add a small extension to their new arc flash LVMCC offerings to keep this phenomenon from occurring.

To connect the fiber to the AFDR, a transition from bare fiber to jacketed fiber is required. This is accomplished through adding a small junction box in a wireway, on top of the LVMCC, or other suitable location. A conduit with the jacketed fiber is routed to the AFDR panel.

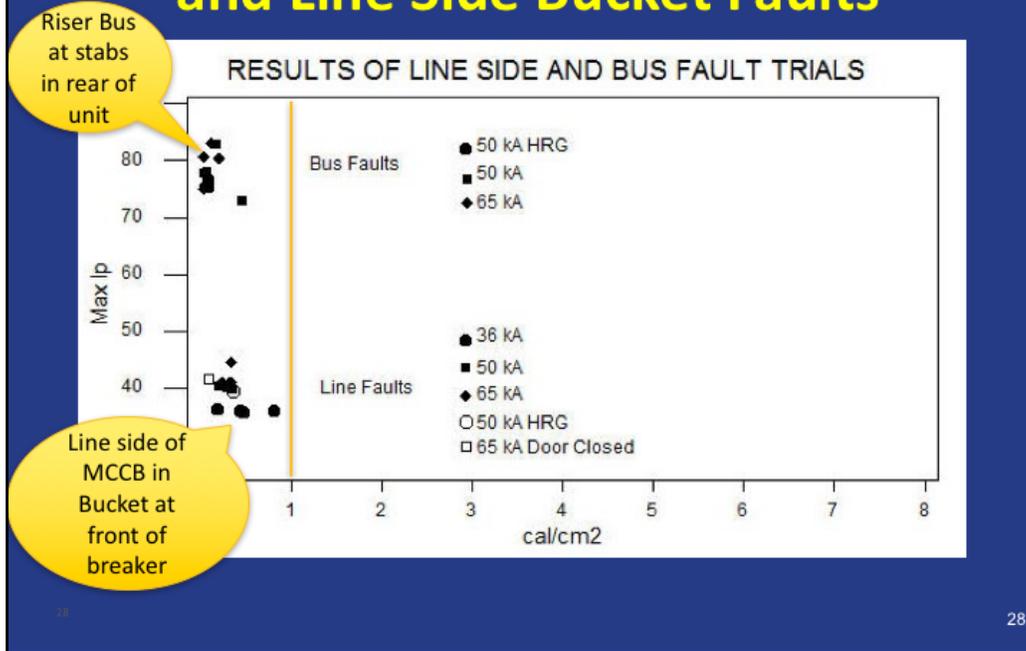
This chart is the summary the calorimeter readings for all tests. The Y axis is the Ip values as the tests did not complete three cycles to calculate rms current, therefore Ip values were used. The X axis is the observed average calorimeter readings. Line faults are the short circuits created on the line side of the circuit breaker as shown in Slide 19. as you can see, the available fault current or grounding had little impact on the actual cal/cm<sub>2</sub> values. The 65kA Door Closed test was an added trial where we could evaluate the open door with modifications versus the typical test with the door closed. As you can see, the values are very similar, proving the effectiveness of the modifications. Also note as stated previously, none of the bucket faults caused the AFDR to operate – they were completely self extinguishing, isolating the failure to that particular bucket without interrupting service to the LVMCC.

Riser Bus faults were initiated as shown on Slide 23 and did involve AFDR operation. All trials resulted in total light saturation of the AFDR light sensing circuit, regardless of position within the structure of the fault. There were 3 trials per each kA rating. As indicated, the grounding system had little impact on cal/cm<sub>2</sub> output. It should be noted that in the bus fault trials, the fault energy has space in the rear that allows the gases to expand without expulsion through the front of the LVMCC, which helps reduce the cal/cm<sub>2</sub> measured in front of the LVMCC.
