# A TESTED METHOD FOR MITIGATING ARC FLASH HAZARDS IN EXISTING LOW VOLTAGE MOTOR CONTROL CENTERS

**Abstract** — This paper develops a practical, cost-effective method of retrofitting existing low voltage motor control centers to reduce the arc flash energy for open door work to a much safer level. These self-extinguishing solutions are designed to reduce the arc flash energy from a calculated value in excess of 40 calories per square centimeter ( $\text{cal}/\text{cm}^2$ ) at an 18 inch working distance to an average tested value of less than 1  $\text{cal}/\text{cm}^2$ .

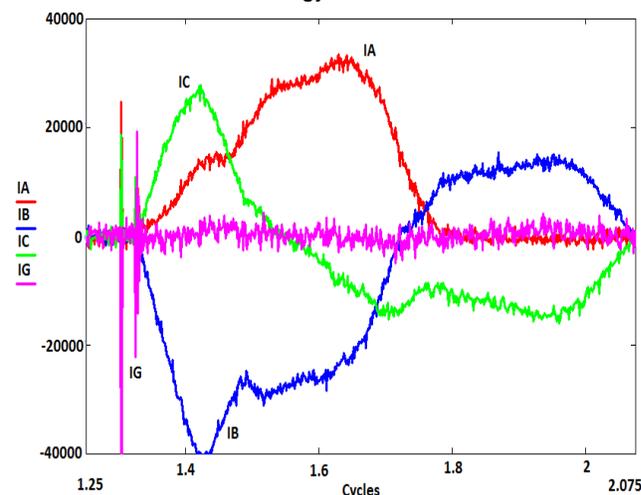
Fig. 1 is the oscillography from Trial 13 of Test Series 2 (Appendix A) [14]. The trial was performed at a prospective current of 50 kA, resulting in a 41.6 kA peak and the arc being sustained for 10.8 ms. The phase currents demonstrate the typical collapse of the arc fault current for an HRG system. The test lab's circuit breaker closed and energized the test sample approximately 1.3 cycles after the data record started. The first 1/10th of a cycle is the time required to melt the #10 bare fine strand ignition wire. At this point the arc develops. A-phase collapses at the first zero crossing failing to re-establish when the anode and cathode swap polarity. Due to the collapse of A-phase, B and C-phases must reposition themselves to be 180 degrees out from each other and the current extinguishes at 2.05 cycles after the data started and 0.65 cycles after the arc began. The circuit remained energized for the full 300 ms to assure no restrike occurred. The arc lasted just over 10.8 ms and the maximum heat energy recorded was 1.14 cal/cm<sup>2</sup>.

Fig. 1 Series 2, Trial 13 Current Oscillography

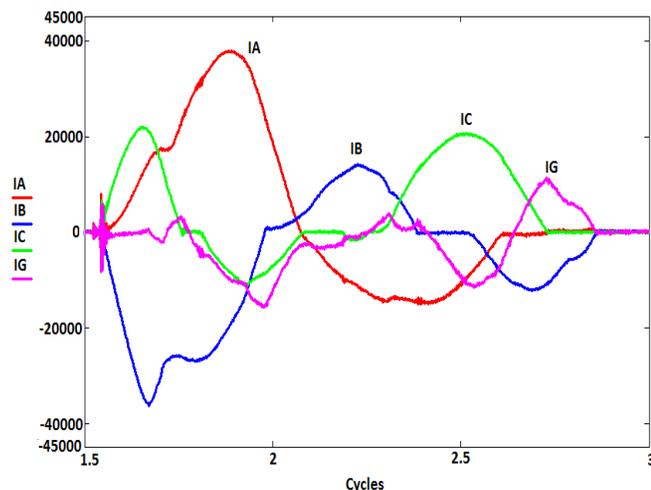
In Fig. 2, Trial 6 of Series 2 phase currents illustrate the

difference a solidly grounded system makes as opposed to an HRG system. This test was performed at a prospective current of 36kA, with a recorded arc fault of 37.9kA peak, with a 21.9 ms arcing time.

The solid ground contributes to sustaining the arc. The test lab's circuit breaker closes ~1.55 cycles after the data acquisition system starts. At 1.7 cycles, the ignition wire melts and the arc begins. C-phase has trouble re-establishing at each zero crossing. At the zero crossing of A-phase, the arc restrikes between A and B-phase with little ground involvement. At 2.25 cycles, the C-phase restrikes and the fault current involves phase A, C, and Ground before restriking to B. At 2.6 cycles, the A-phase arc extinguishes, followed by C-phase, so the fault for the last 1/8th cycle is B-phase arcing to ground.

Fig. 2 Series 2, Trial 6 Current Oscillography

A-phase arced to the braid preventing the plasma field from developing sufficiently to sustain through the zero crossing. There was evidence of arcing between A and B-phase. The prospective current for this trial was 36kA rms, but the last 1/2 cycle of current crested at less than 20kA. The maximum incident energy recorded was 1.35 cal/cm<sup>2</sup>.

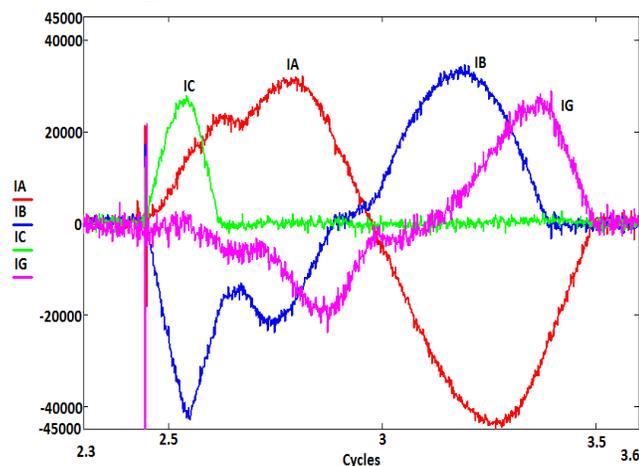
Fig. 3 Series 2, Trial 8 Current Oscillography

In the second trial of a solidly grounded system, (Fig. 3) the

arc fails to reverse polarity through the zero crossing at this voltage level for C-phase. Due to the proximity of the ground plane, the arc does not develop to a maximum energy transfer condition, as discussed in Paper 2 [3]. As the polarity shifts, it becomes impossible for a stable plasma field to re-establish over the resistance created by the bucket modifications.

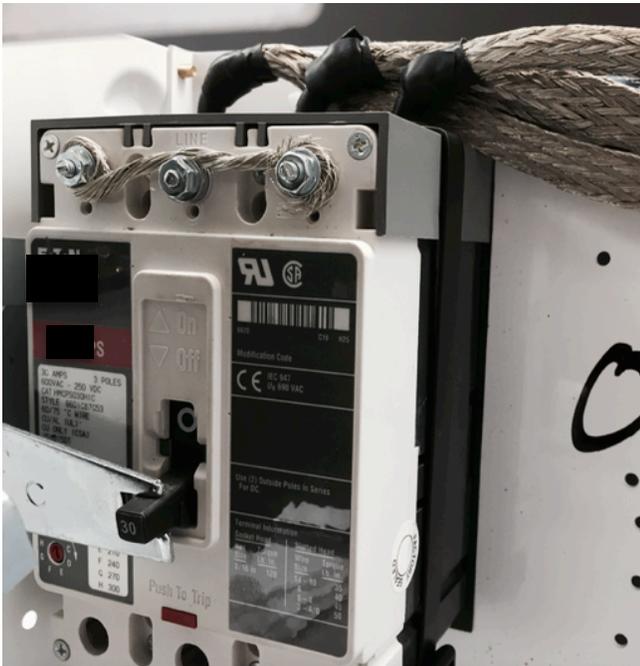
During testing, several methods were developed to secure the bare #10 fine strand ignition wire used to initiate the arc. The most effective method removed the line side terminals from the MCCB to be drilled and tapped for the terminal screw to receive an 8-32 screw after reinsertion into the breaker. For line side faults this method used a 1-1/2 in., 8-32 zinc machine screw, (2) #8 flat washers, and (2) 8-32 nuts as shown in Fig.4. The bare #10 fine strand ignition wire was secured to the machine screws by clamping a loop of the ignition wire between the two nut and washer combinations. The machine screw head was then cut off as close as possible to the nut.

Fig. 4 Bus stab ignition wire connection

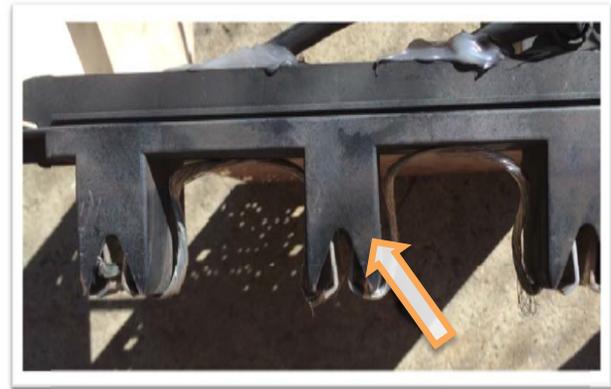
To perform the bus faults, the ignition wire was wrapped around each of the bucket stabs, as shown in Fig. 5. The combination starter unit was then stabbed onto the riser bus and the calorimeters were mounted 18 inches from the front of the unit with the door open.

Fig. 5 Bus stab ignition wire connection

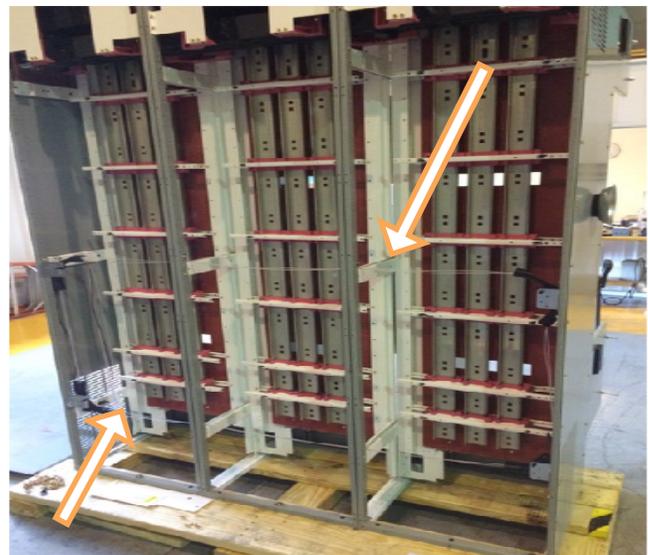
The arc flash detection relaying scheme requires the addition of relay class current transformers (CT) in the LVMCC feeder circuit, a trip signal from the arc flash detection relay to the LVMCC feeder circuit breaker at the low voltage switchgear, and the installation of a bare fiber loop with associated supports and bulkhead fittings (Fig. 6 and 7). The light sensing fiber is installed in the rear bus compartment by removing only the two side panels of the LVMCC and using screw together fiberglass pulling rods (fish sticks) to pull in the fiber. During testing, three donut style CTs were installed on the incoming bus and one donut style CT was installed on the grounding conductor. The ground CT was used only for data gathering and was not part of the AFDR relaying scheme. The AFDR trip outputs were wired into the test facility's backup circuit breaker to interrupt faults detected by the relays. Only one AFDR was actively tripping during any test but both AFDRs were in service and recording fault data. Both AFDRs worked well and as expected throughout the tests.

Fig. 6 Bus compartment fiber optic loop installation from bulkhead fitting in the bottom left of picture over lower support brackets and return over midway support brackets. (Rear panels removed for clarity)

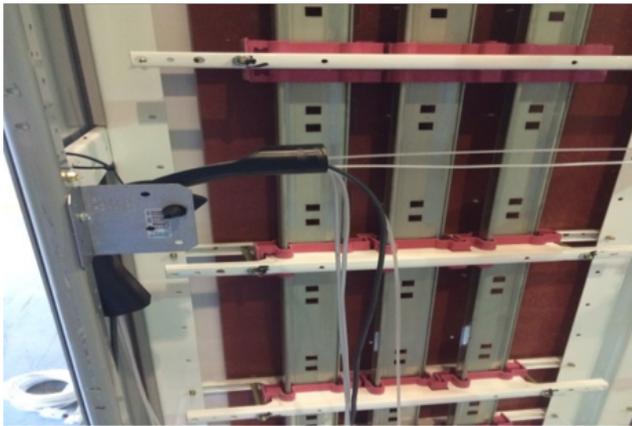
Fig. 7 Supports for bare fiber loop installation both manufacturers' relay loops routed together.

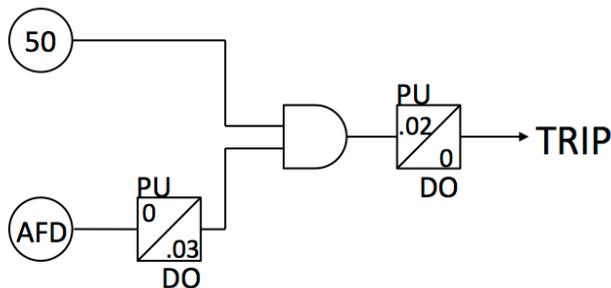
A 30 ms dropout timer was added to the light detection element to "latch" the light pickup due to the instability of the arc, ensuring the light detection input remains asserted in case of a AFD failure before the overcurrent delay times out. (Fig. 8)

Fig. 8 Tripping Logic for one AFDR used

The light detection element (AFD) of the AFDR is supervised by an overcurrent element (50) to prevent false tripping due to inadvertent exposure to bright light. The current pickup was set based on the load current rating of the horizontal bus and the locked rotor current of the largest motor that would be installed on the low voltage system, 250 HP ( $3200A + 6(1.25 \times 250) \approx 5000A$ ). The time delay (62) is used for tripping security to allow the arc extinguishing modifications and the MCCB to control fault current extinguishing or clearing times in the bucket or the downstream circuit. Therefore, the AFDR will only send a trip signal to the upstream circuit breaker for a fault in the bus section of the LVMCC.

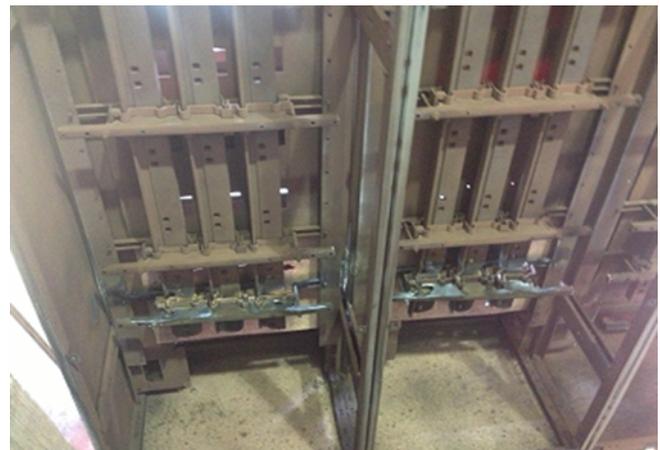
It was observed in Test Series 1 and 2 that very little energy from a fault in the bus section in the back of a LVMCC that lasts 200, 300, or even 500 ms makes it to the front of the equipment. In both insulated and uninsulated riser bus arrangements, the fault traveled to the bottom of the riser bus and rooted, vaporizing several inches of the riser bus and contaminating the entire sample with copper and decomposed polymer (Smoke) residue from the pyrolysis of the insulation as seen in Fig. 9.

Fig. 9 Remaining rear compartment after 300ms 50kA fault

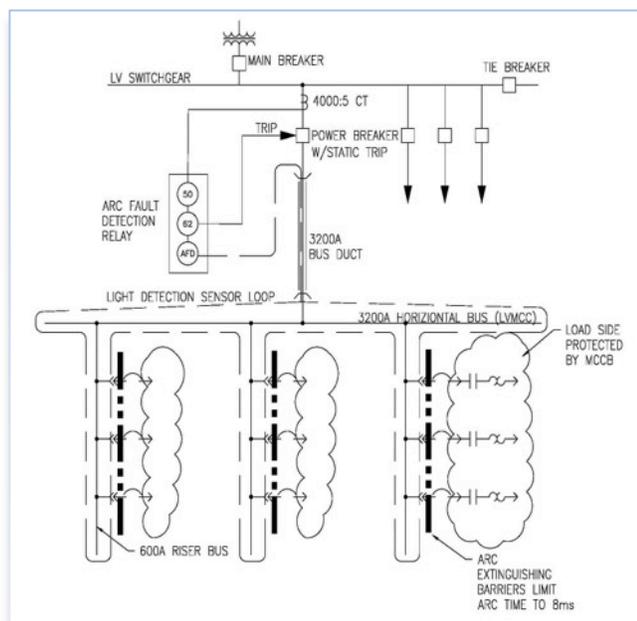
The intention of the AFDR is not to reduce the incident energy at the front of the LVMCC but to limit the damage, thus reducing MTTR if a fault develops in the bus area. The system requires the installation of a set of current transformers in the switchgear, the mounting of the AFDR, installation of the fiber optic sensing loop and installation of an externally powered shunt trip on the feeder breaker if the breaker has only an integral trip unit. The existing protection system does not

require any other modifications and will act as it has in the past. (Fig. 10)

Fig. 10 Arc Flash Detection Protection One-Line Diagram

When viewed in the overall system one-line diagram, (Fig. 10) this paper introduces an effective method to reduce the risk of open door work to an acceptable level while eliminating fault propagation between the bucket and the rear compartment riser bus. Further, the solution offers high-speed protection for faults when they do occur, while limiting the shock hazard locations available.

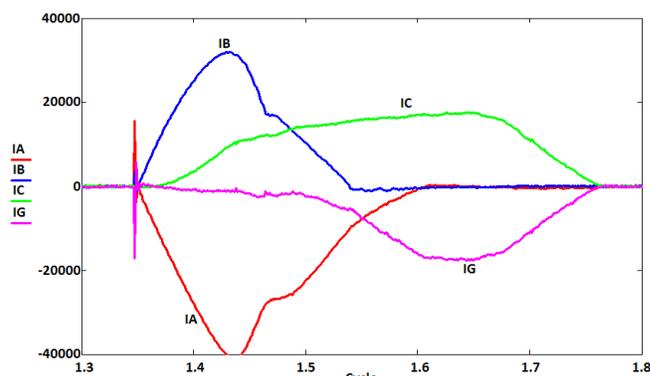
1. Fig. 11 shows the typical extinction pattern witnessed in the line side faults. The B-phase would be the first to collapse at approximately 3 ms followed by A-phase and the final arc would be C-phase-to-ground. This sequence appears to be the result of the geometry of the magnetics and its impact on the arcing fault.

Fig. 11 Typical 63kA prospective line side fault extinguishing pattern for solidly grounded system

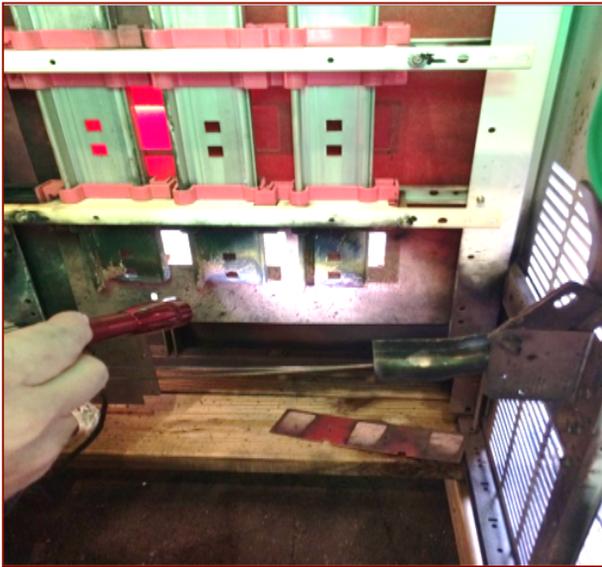
2. Load side initiated faults were all interrupted in less than ½ cycle by the MCCB in all cases but one, where a poor bus stab connection resulted in a riser bus fault that was cleared by the AFDR tripping the test lab circuit breaker. The use of the AFDR provided a distinct advantage in mean time to repair with arc faults in the bus section of the LVMCC. (Fig 12)
3. Both the operation of the buckets' MCCB under fault condition and the line side bucket fault existing until extinguished by the bucket modifications generate a flash of light. The AFDR event report in Fig. 13 (line side fault, door closed) shows the fault clearing in approximately 7 ms with the light detected in the rear of the LVMCC at less than 1% of the maximum light detection level of the relay. The arc fault self-

Fig. 12 Minimal bus damage after riser bus fault cleared by AFDR

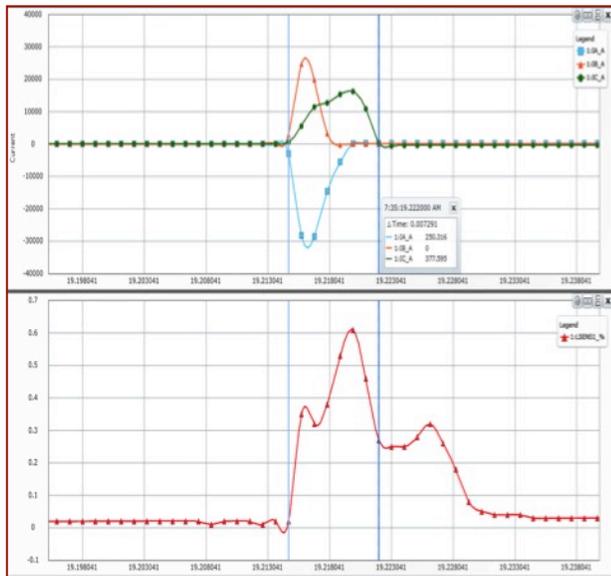
Fig. 13 63kA Prospective current, line side fault with door closed. The top graph shows the current oscillography for the 7msec the fault lasted and the bottom graph show the light buffer internal to the AFDR as reported by the relay software.

4. The fault recorded in Fig. 14 (line side fault, door open) lasted just over 10ms with a maximum light detection of approximately 1.5% of full scale and no other device acted to clear the fault. The arc self-extinguished as was typical for this series of tests.
5. Figs. 13 and 14 show AFDR oscillography for the line side faults with door closed and door open. Consistently, the bucket faults in various locations of the LVMCC frame recorded less than a 1% increase

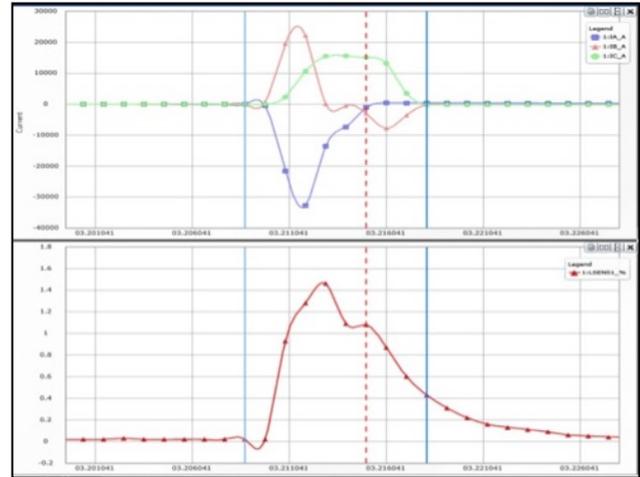
over the background light level for the flash created by the breaker interrupting a non-arcing fault. For an arcing fault generated on the line side of the bucket circuit breaker, a sensor level of 1.5% over the background light detection level was the maximum recorded.

Fig. 14 63kA Prospective current line side fault with door open. The top graph shows the current oscillography for the 10msec the fault lasted and the bottom graph show the light buffer internal to the AFDR as reported by the relay software.

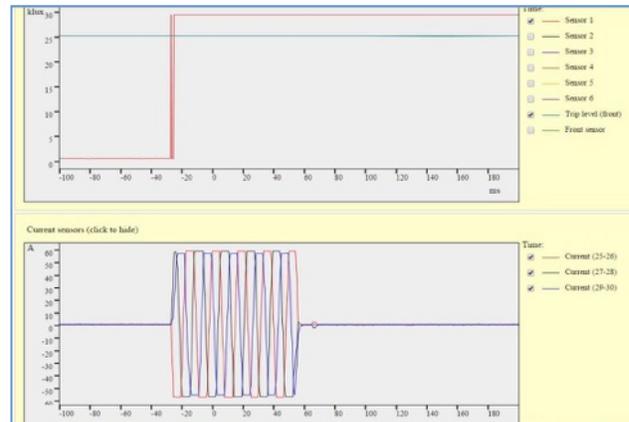
6. In Fig. 15 and Fig 16, the result of a fault in the rear of the LVMCC recorded a light level of 100% of the relay light detection range and in the case of one manufacturer's AFDR, the lux level was consistently high enough to drive the light detection transducer into saturation.

Fig. 15 Typical waveforms for Arcing Fault in Bus section as reported by one of two different AFDRs

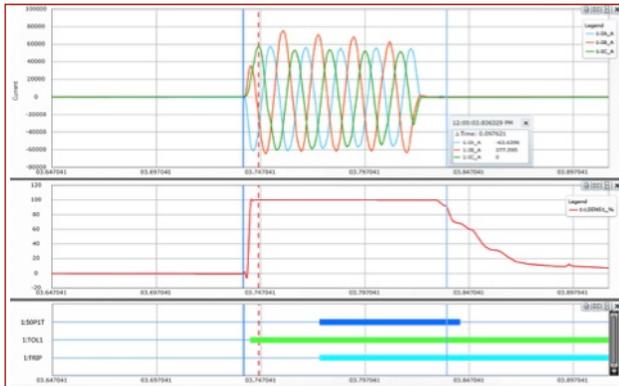
- Fig. 16 Typical waveforms for Arcing Fault in Bus section as reported by second of two different AFDRs

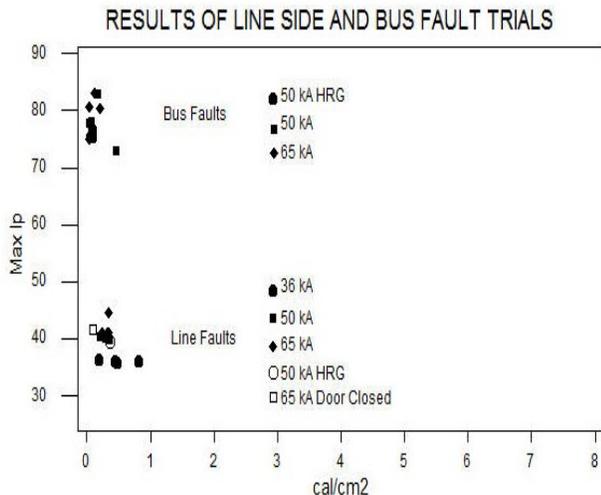
The summary of the results of the faults initiated on the line side of the LVMCC bucket's MCCB and cleared by the arc extinguishing modifications (line side) and the faults initiated at the stabs and cleared by the AFDR (bus faults) are shown in the Fig. 17. The results clearly show that for the 35 trials in

Test Series 3, no results indicated an average calorimeter reading greater than 1 cal/cm<sup>2</sup>.

Fig. 17 Final results of riser bus fault and bucket line side fault trials

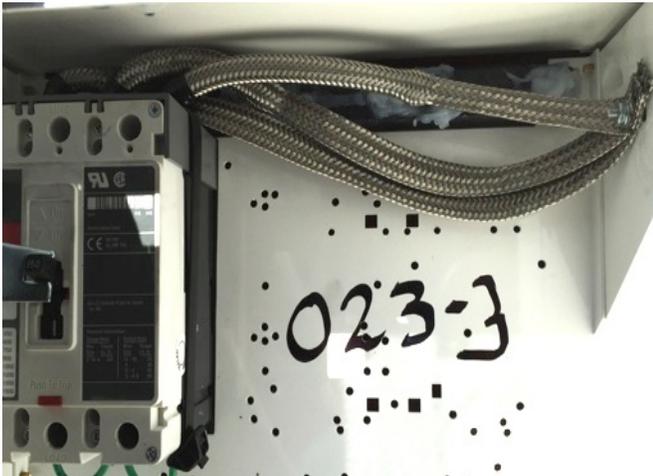
The design concepts work well in LVMCC, taking advantage of normal phase spacing, low driving voltages at the arc and the instability inherent in low voltage arcs due to the magnitude of the resistance injected into the circuit during an arcing fault. The test series finalized a set of design modifications. (Fig. 18 shows the bucket modification)

Fig.18 Final Bucket Modifications (1) breaker cover with cable tie, (2) grounded braid sleeve, (3) caulked stab assembly

1. MCCB Cover – The MCCB cover appeared to limit the ability of the arc to propagate within the motor control unit by placing a barrier that stretched the arc length between the breaker terminal and metal surfaces.

2. Silicone Caulk – Simply sealing the line leads at the glass polyester clamshell provides a barrier for the plasma field and prevents propagation of the arc fault to the riser bus.

3. Grounded tinned copper braid – The tinned braid protects against arc propagation if the leads blow out at the top of the MCCB. As mentioned before, the ground plane works to kill the arc by making the low impedance path a ground fault. The braided tinned copper sleeve draws any faults to ground, rather than allowing faults to develop into phase-to-phase faults. Further, the braid shortens the arc path and limits the free electron/plasma field created. In the case of the HRG, this results in a 5A fault, and in the case of the solidly grounded system, the reduced impedance to ground prevents the fault from surviving the next zero crossing since the energy is too low to sustain the plasma field.
